Orbital Transfer Rocket Engine Technology Program

Contract NAS3-23773
Task B.5

Soft Wear Ring Seal Technology

FINAL REPORT

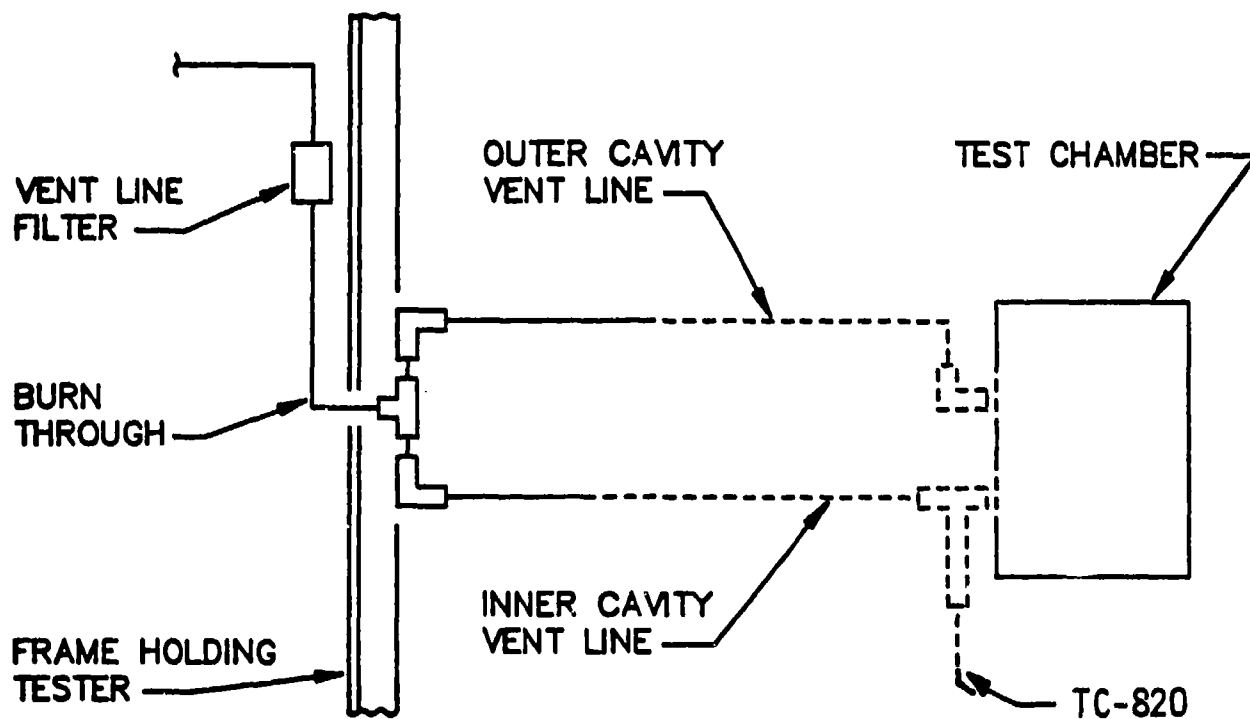
Figure 17. Schematic of Test Chamber Outlet Lines

It was noted that there was a burn-through in the wall of the AN tubing at the 90° bend downstream of the connection of the two outlet lines, as shown in Figure 17. The burn-through is also shown in Figure 8. From this photograph it should be noted that the location of the burn-through is behind the frame of the tester, when viewed from the video camera.

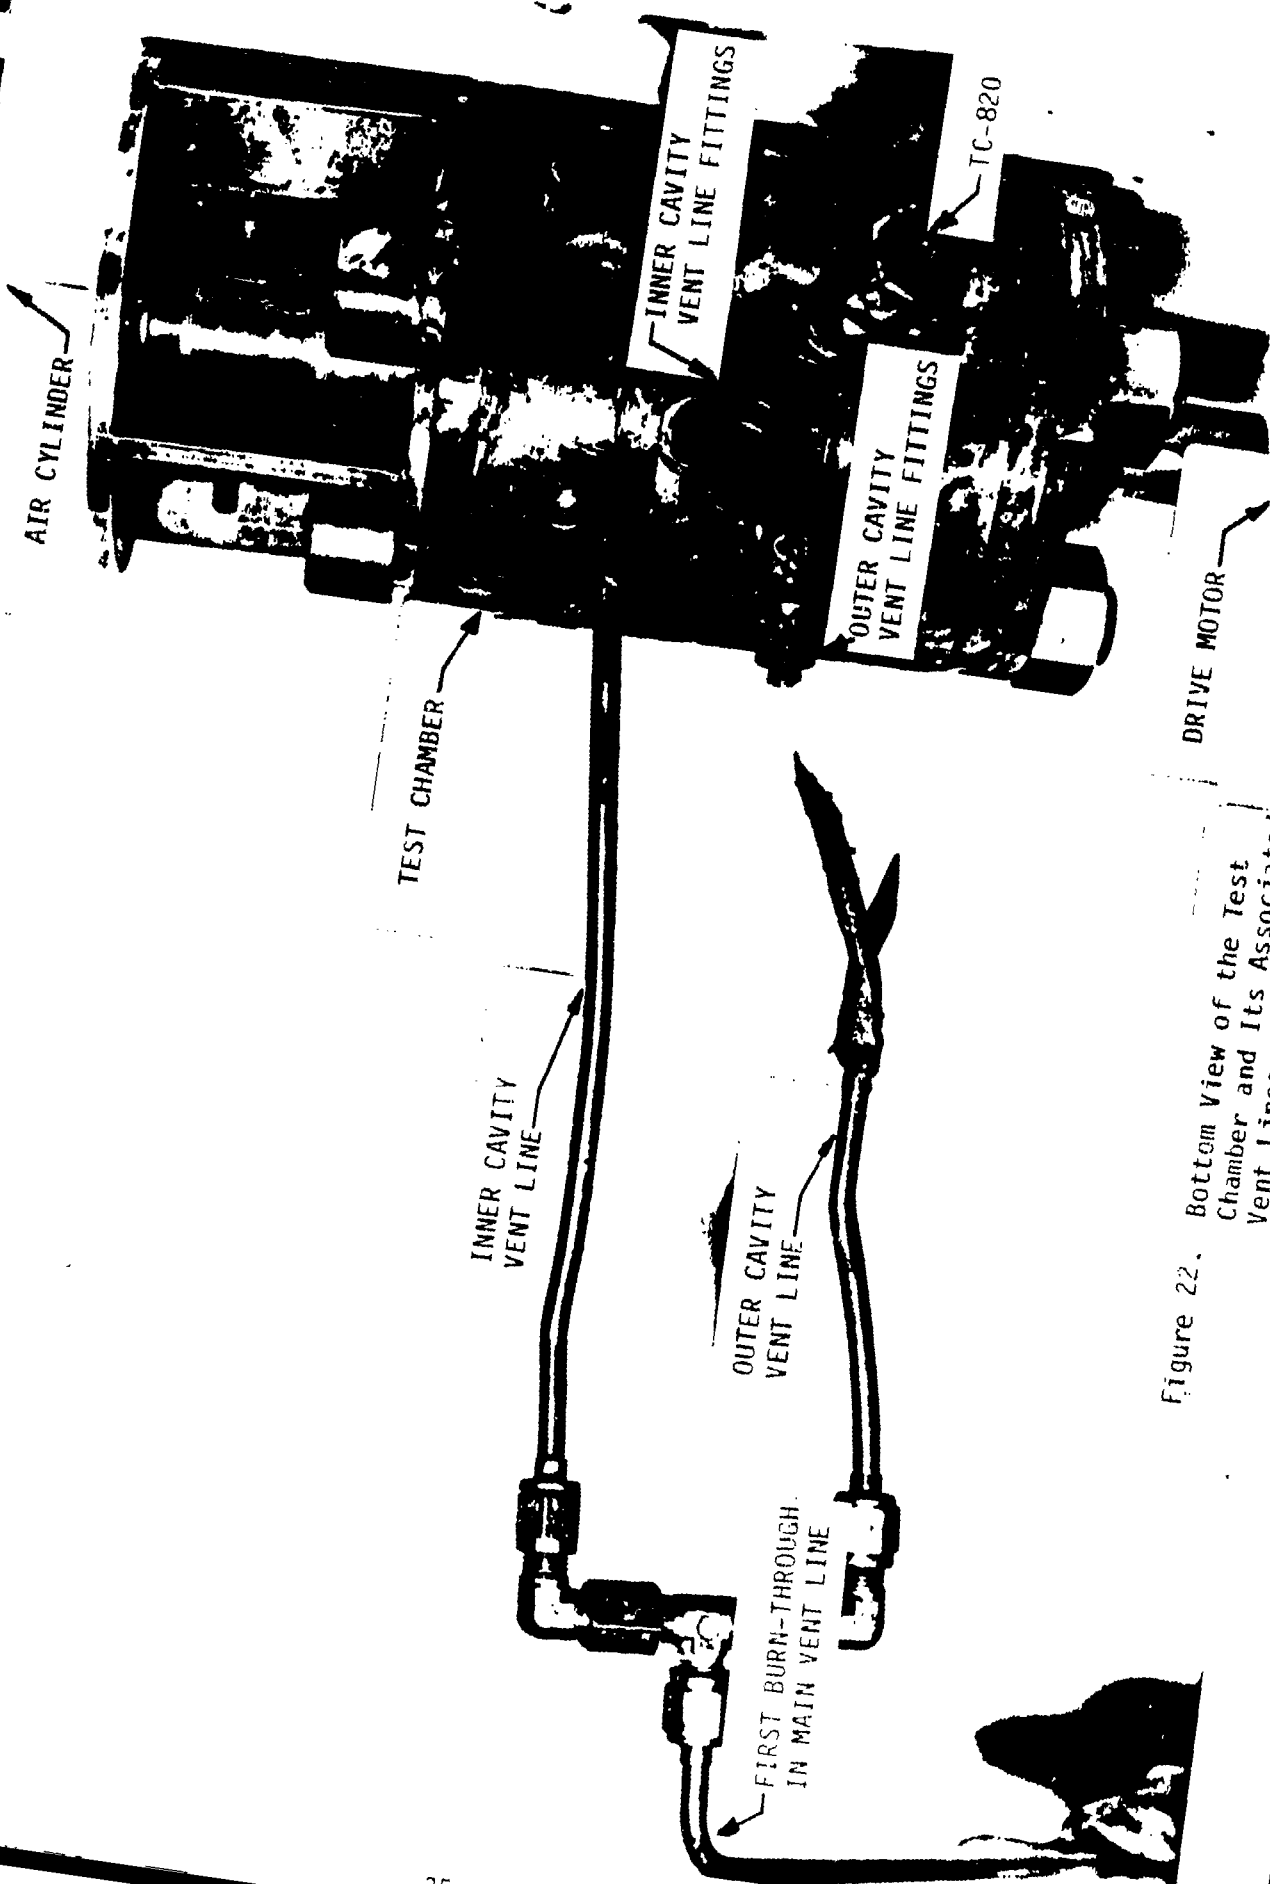
Figure 22. Bottom View of the Test Chamber and Its Associated Vent Lines and Fittings After Being Removed from the Test System

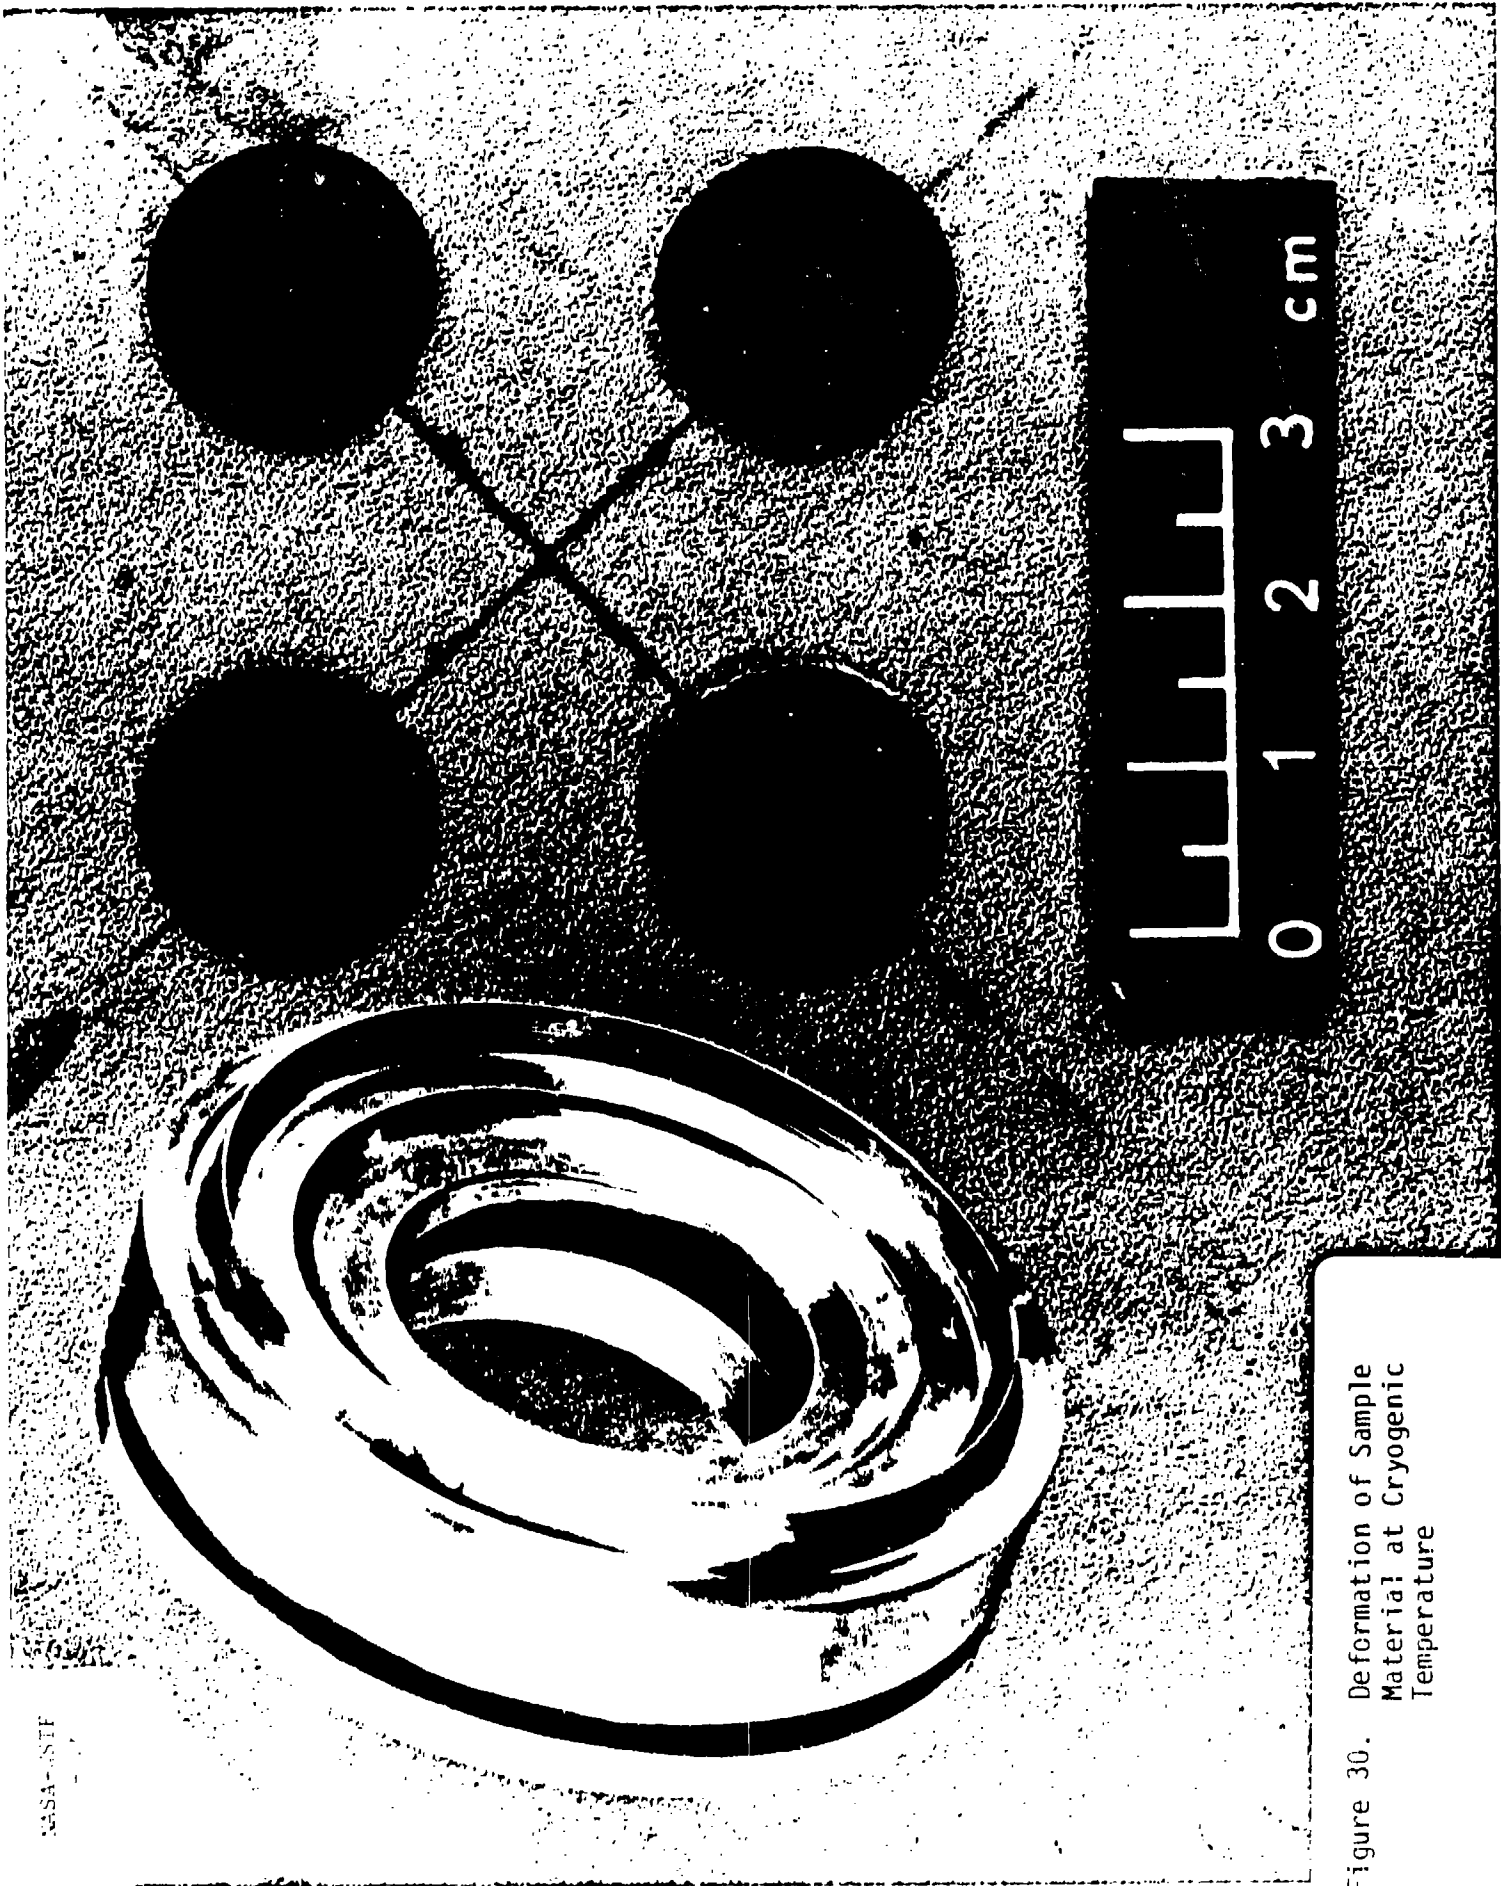
Figure 30. Deformation of Sample
Material at Cryogenic
Temperature

discs were attached to a 1/4-inch-thick, stainless steel plate using epoxy. The rotor was placed on top of the discs and an 11,300 lb/sq in load was applied and held for several seconds. The results of the experiment are shown in Figure 29. The rotor made a slight, nearly imperceptible mark in the surfaces of the discs. The experiment was then repeated after the rotor and the discs were cooled in liquid nitrogen, and the results are shown in Figure 30. Again, it was found that only a very slight impression had been made in the test sample material. As a result of this experiment, it was determined that the load applied to the samples in the pretest setup did not damage the test sample surface.
